NASA TECHNICAL MEMORANDUM

NASA TM X-64846

MSFC SKYLAB ATM CALIBRATION
ROCKET PROJECT

Skylab Program Office

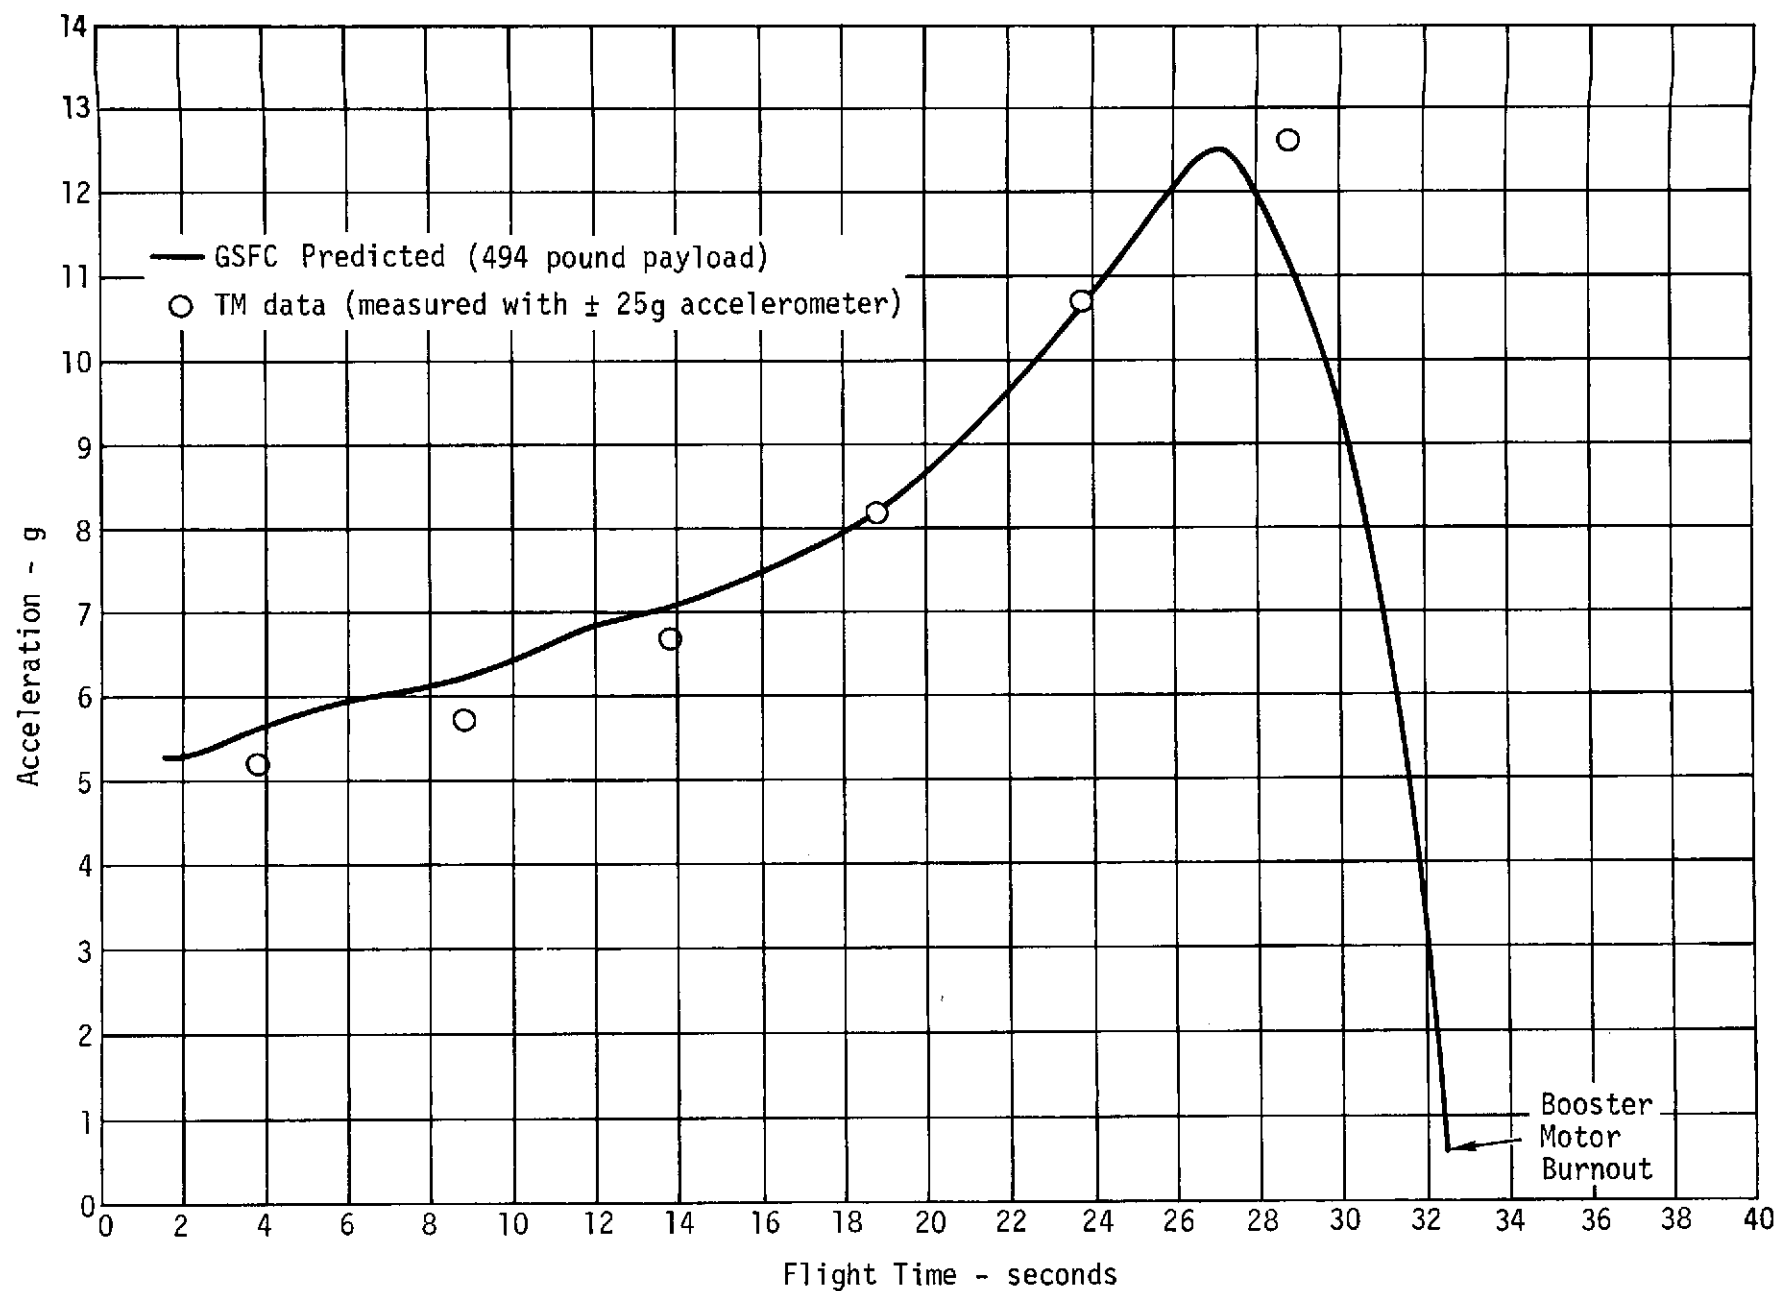
Figure 7-2. Flight 21.022 Longitudinal Accelerometer

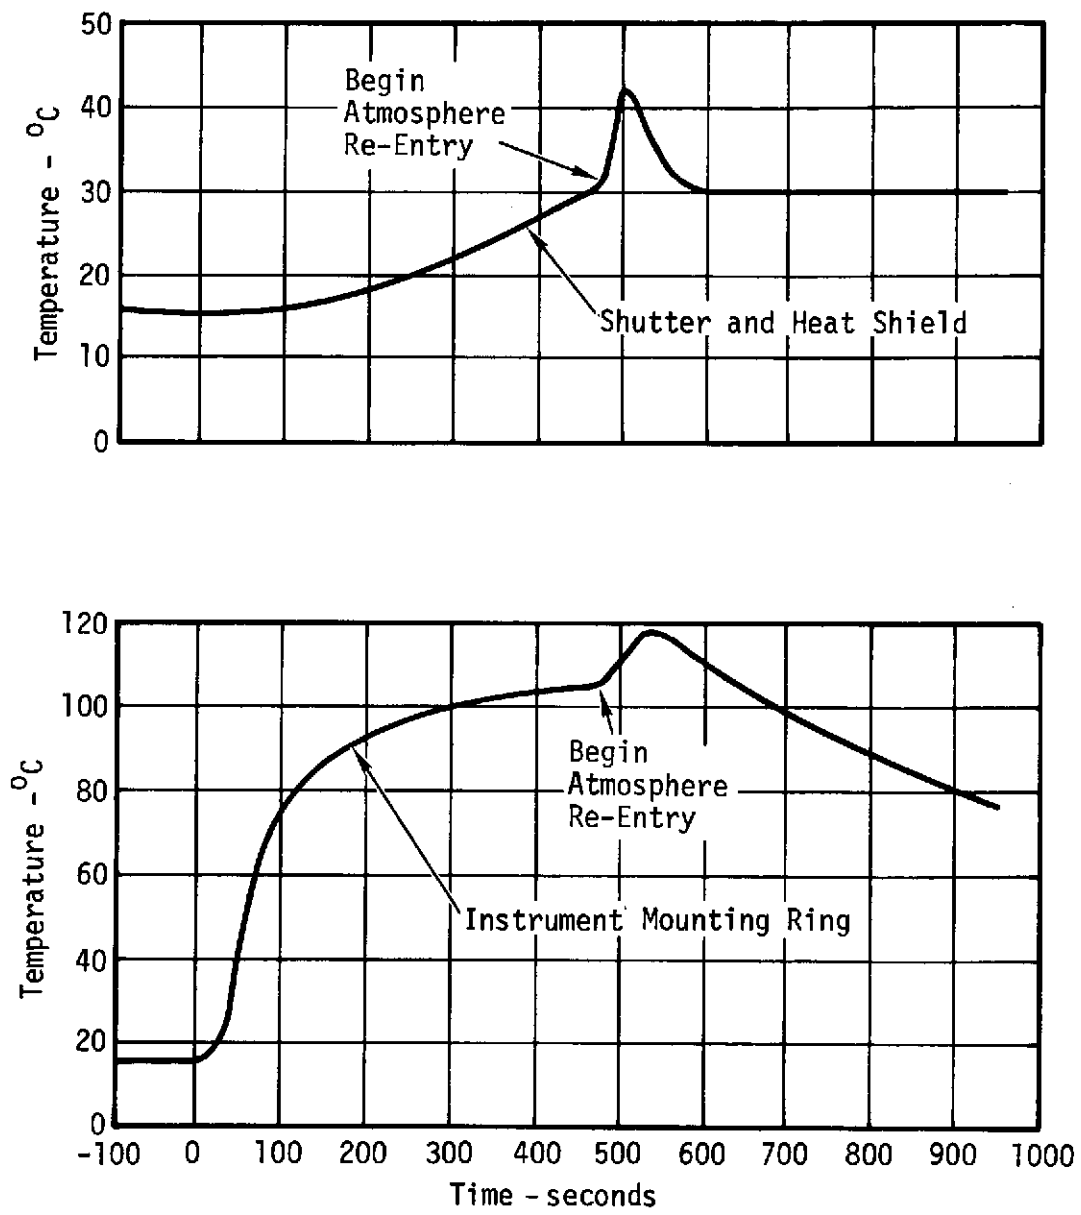
Figure 7-5. CALROC 21.022 Scientific Instrument Flight Temperatures

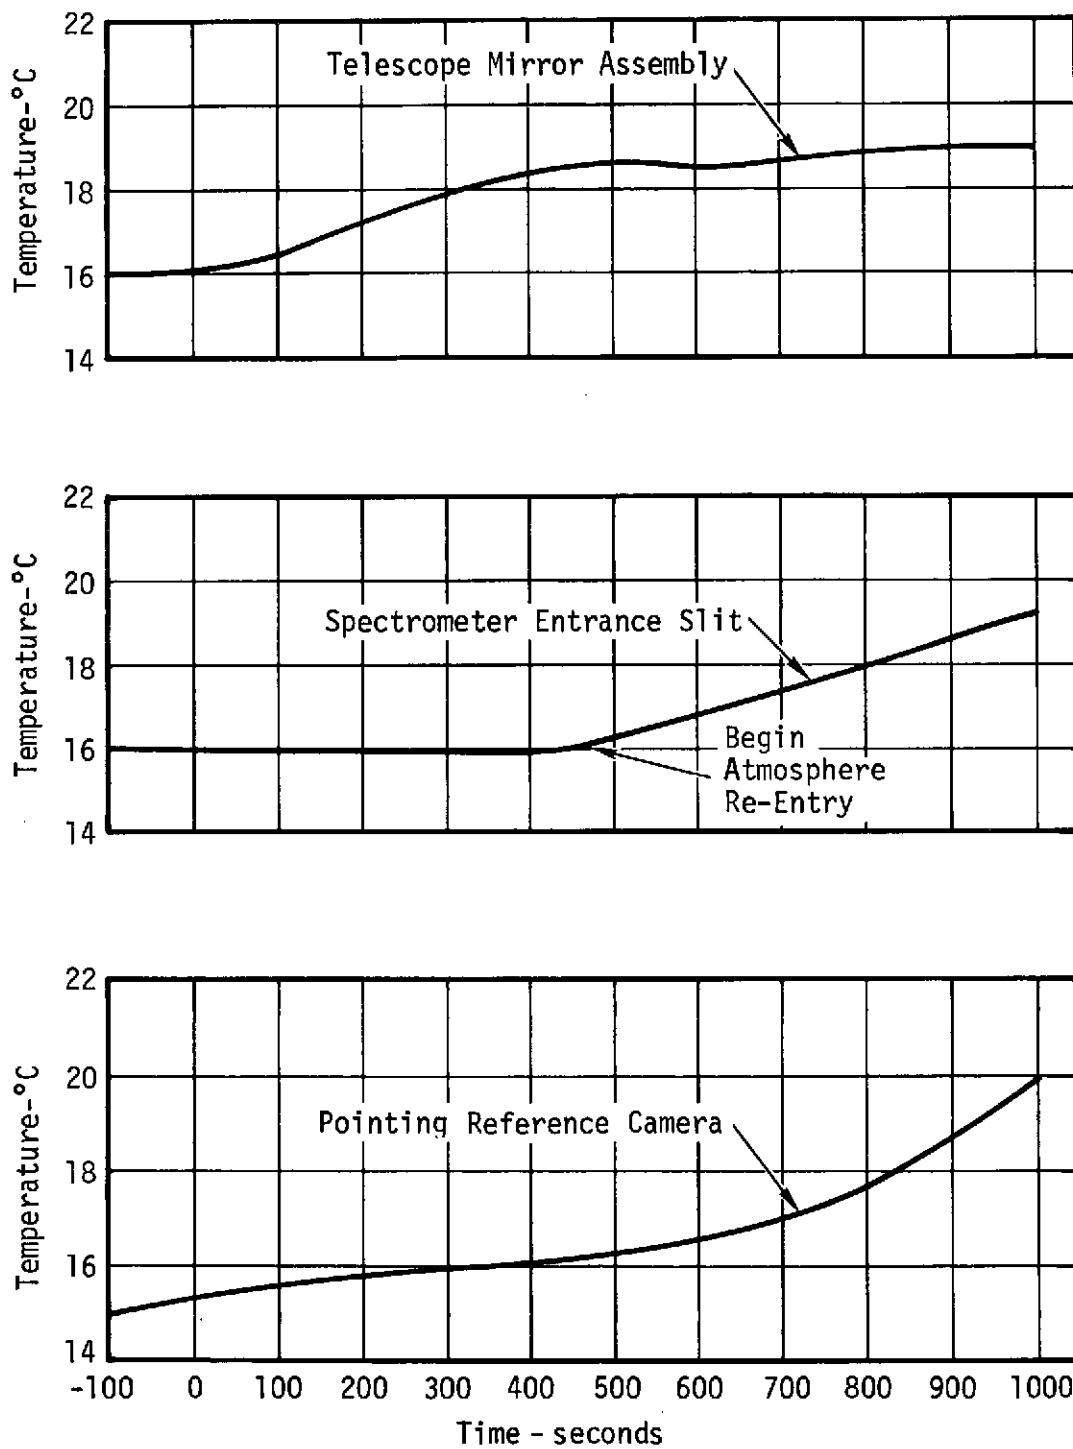
Figure 7-6. CALROC 21.022 Scientific Instrument Flight Temperatures

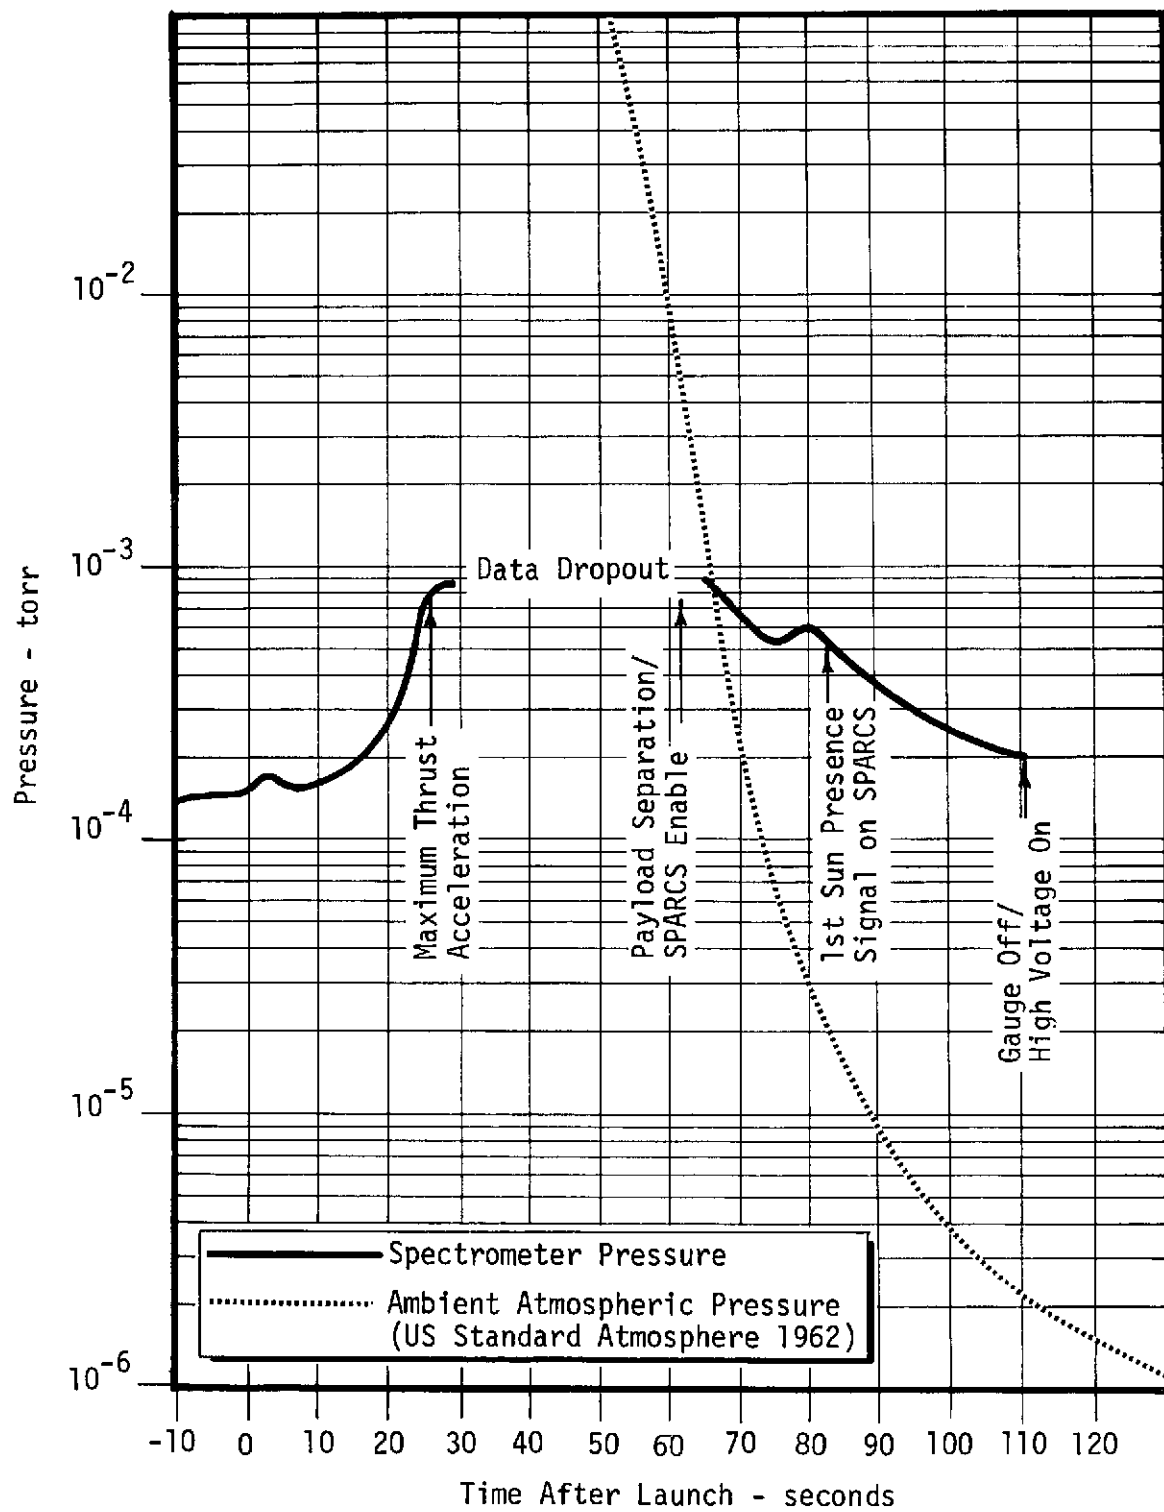
Figure 7-7. CALROC 21.022 Scientific Instrument Flight Pressure
